Home Inspection Report

Property Address:

Any Street

Inspected on Wed, Mar 21 2012 at 3:03 PM

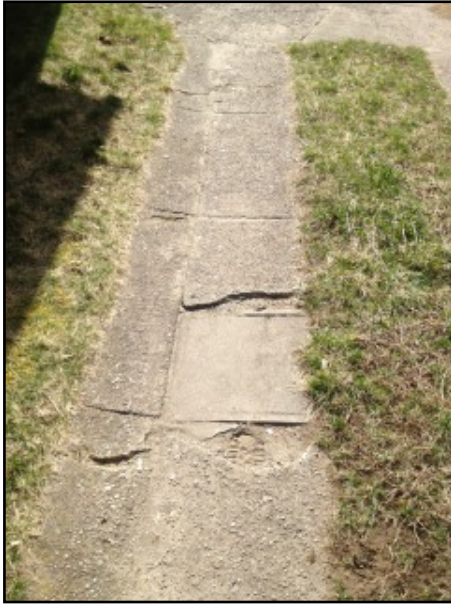
Figure 1-1

**Comment 1:**
Driveway shows minor wear and tear normal for age of driveway still in satisfactory condition.

1) Driveway shows minor wear and tear normal for age of driveway still in satisfactory condition.

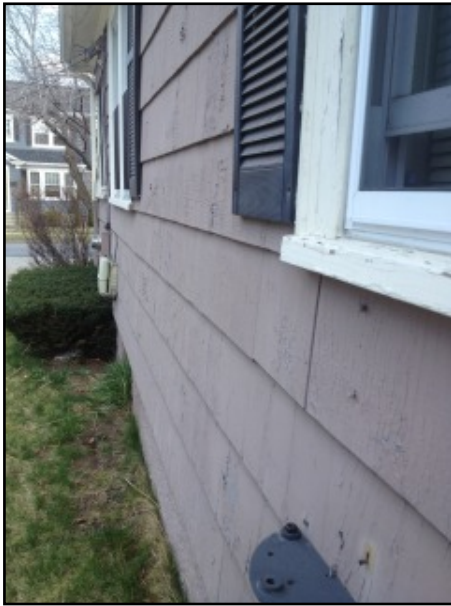
Figure 2-1

Entire area around house including siding and trim paint system has failed should be addressed and repainted to prolong the life of wood exterior.

2) Entire area around house including siding and trim paint system has failed should be addressed and repainted to prolong the life of wood exterior.

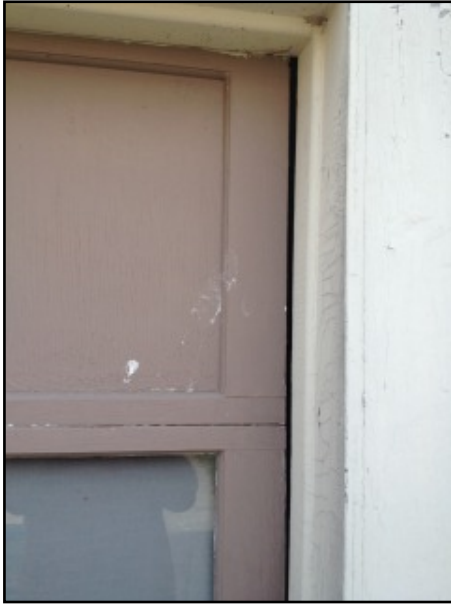
Figure 3-1

Left garage door not square as shown by gap on right side of door.

3) Left garage door not square as shown by gap on right side of door.

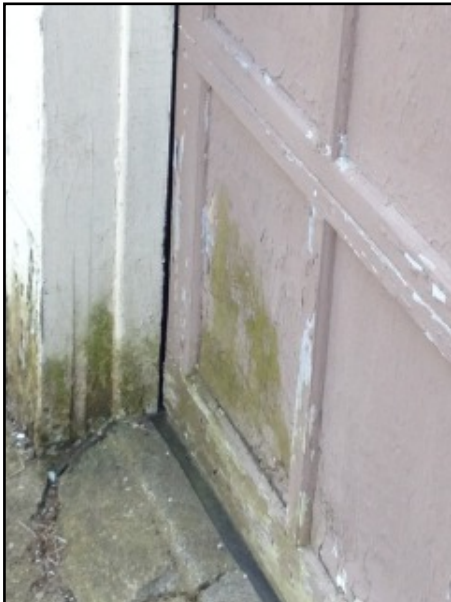
Figure 4-1

**Comment 4:**
Severe wear and deterioration of wood in several areas around garage recommend replace or repair consult qualified contractor.

4) Severe wear and deterioration of wood in several areas around garage recommend replace or repair consult qualified contractor.

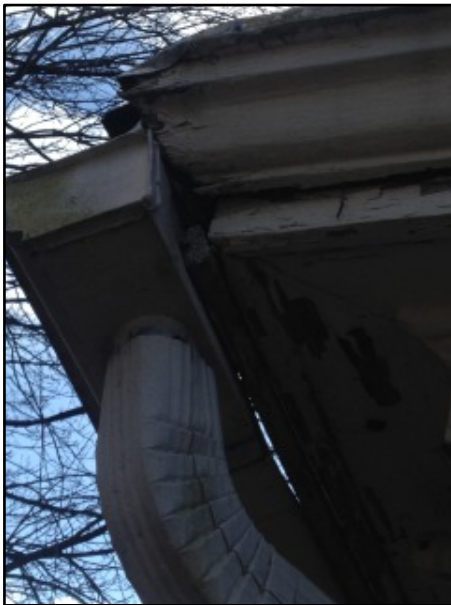
Figure 5-1

Gutters pulled away from fascia board and worn should be repaired or replaced by qualified contractor.

5) Gutters pulled away from fascia board and worn should be repaired or replaced by qualified contractor.

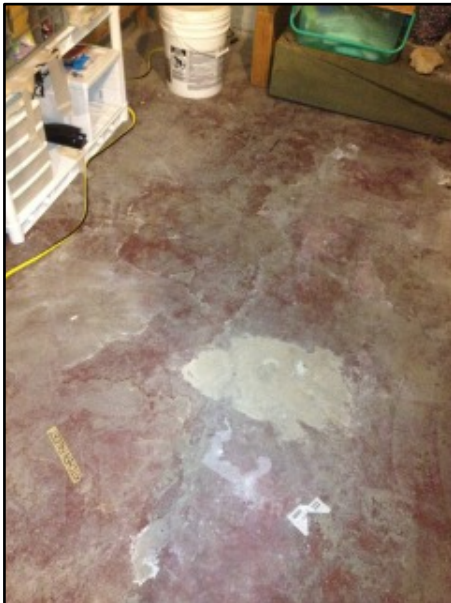
Figure 7-1

Evidence of marks on the floor suggest water was present at one time suggest further evaluation by qualified contractor.

6) Evidence of marks on the floor suggest water was present at one time suggest further evaluation by qualified contractor.

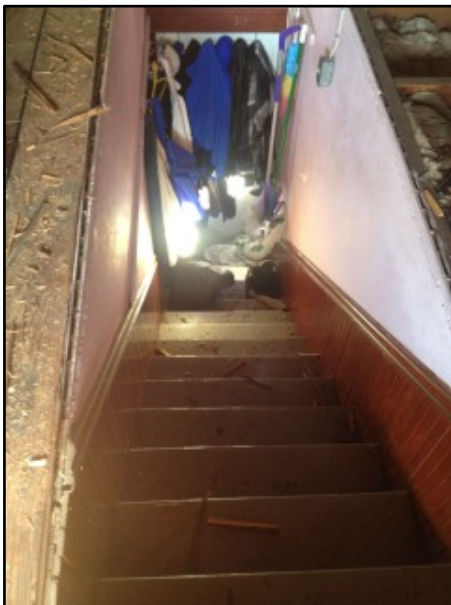
Figure 8-1

No handrail present on attic access stairwell install railing.

7) No handrail present on attic access stairwell install railing.

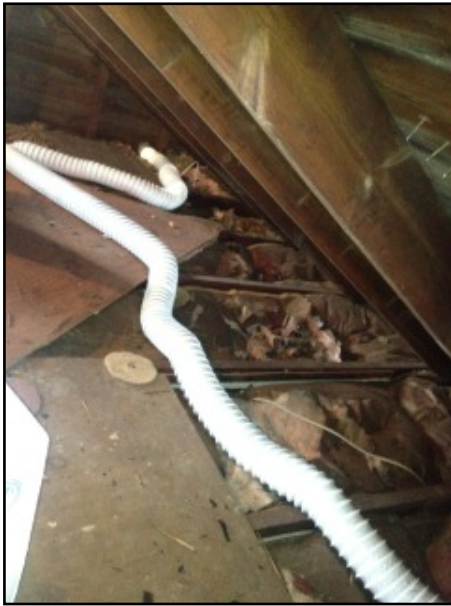
Figure 9-1

Bath vent does not take direct route to exterior of structure should be repaired by a qualified contractor.

8) Bath vent does not take direct route to exterior of structure should be repaired by a qualified contractor.

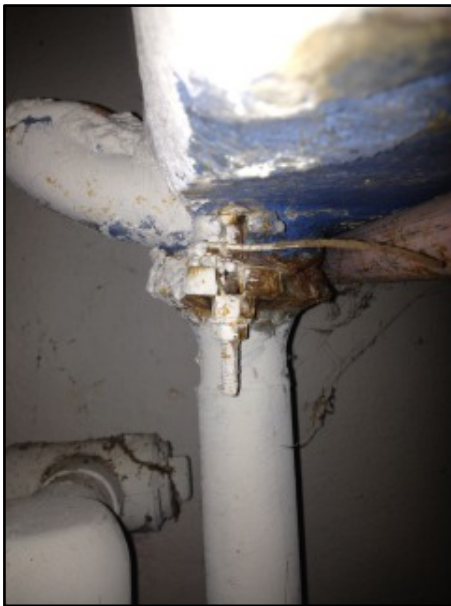
Figure 10-1

The plumbing waste line is rusted and deteriorated at P-trap.

9) The plumbing waste line is rusted and deteriorated at P-trap.
